WW II B17 Survival Story

B-17 "All American" (414th Squadron, 97BG) Crew

B-17 in 1943

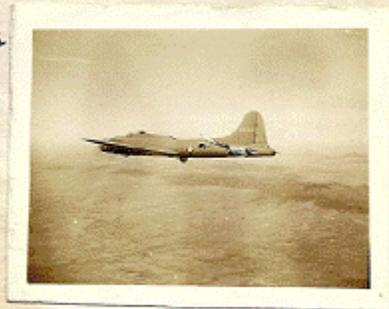
DAMAGE COURTESY OF
Willie Messersmith
X His Mark
R.I.P.

OLD "ALL-AMERICAN" "SOMEWHERE OVER NORTH AFRICA"
FEBRUARY 1, 1943

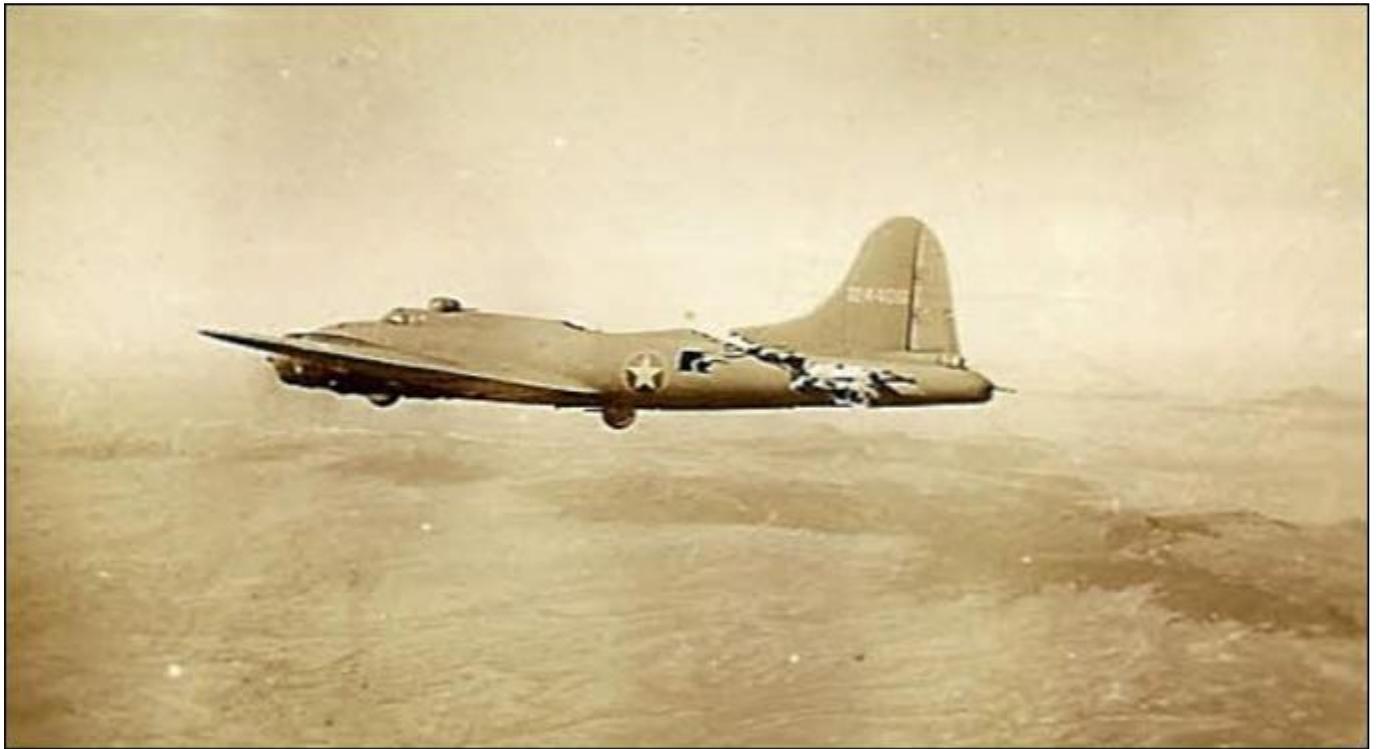
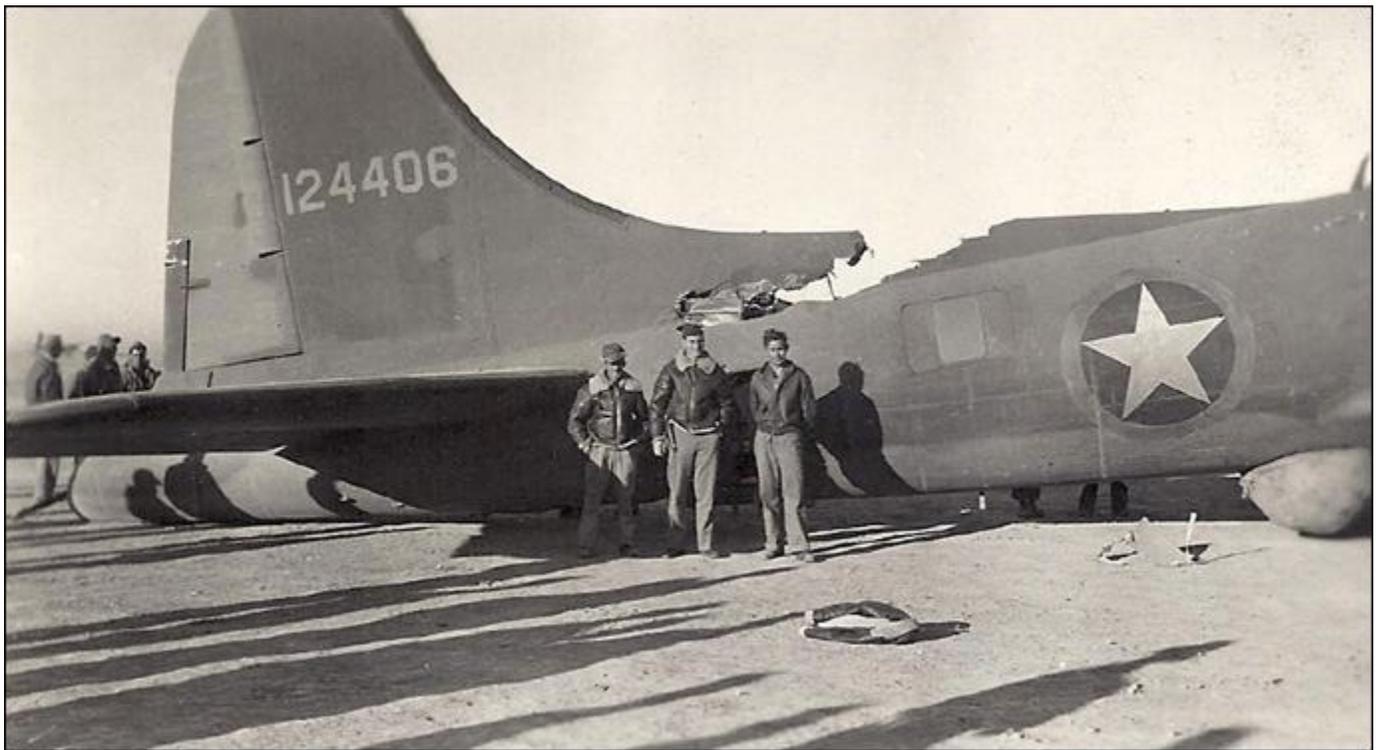
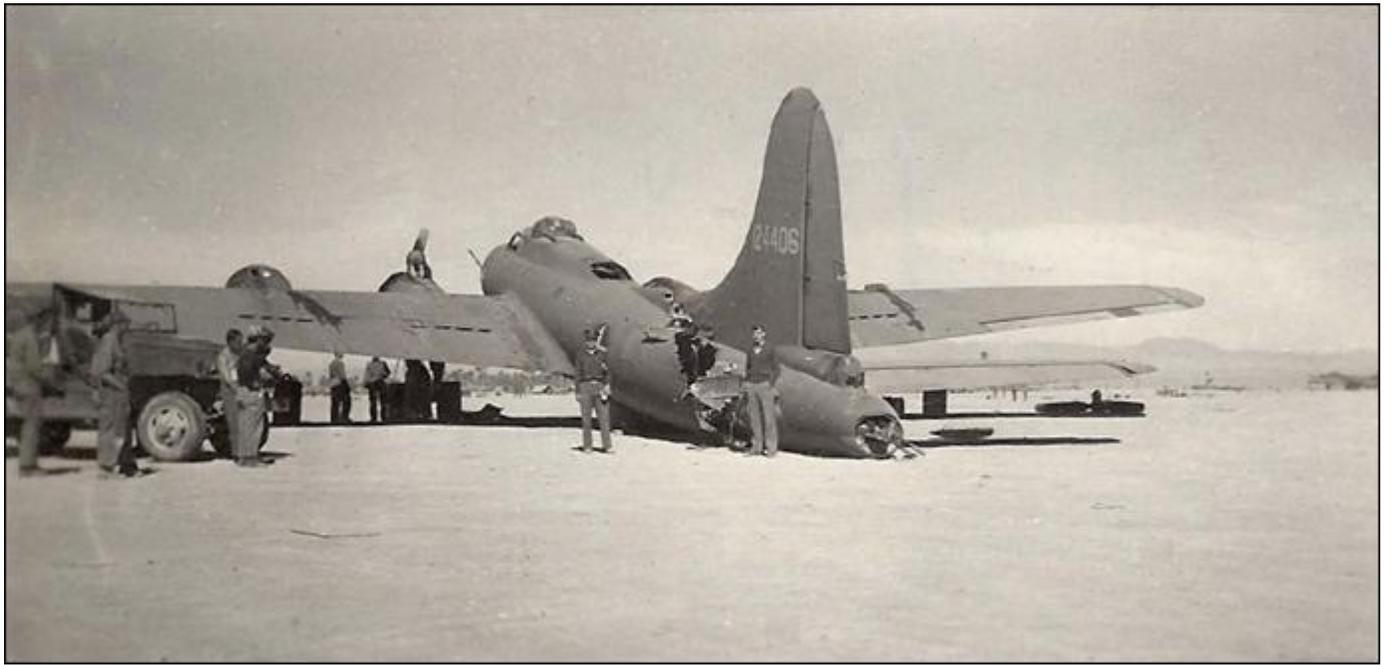
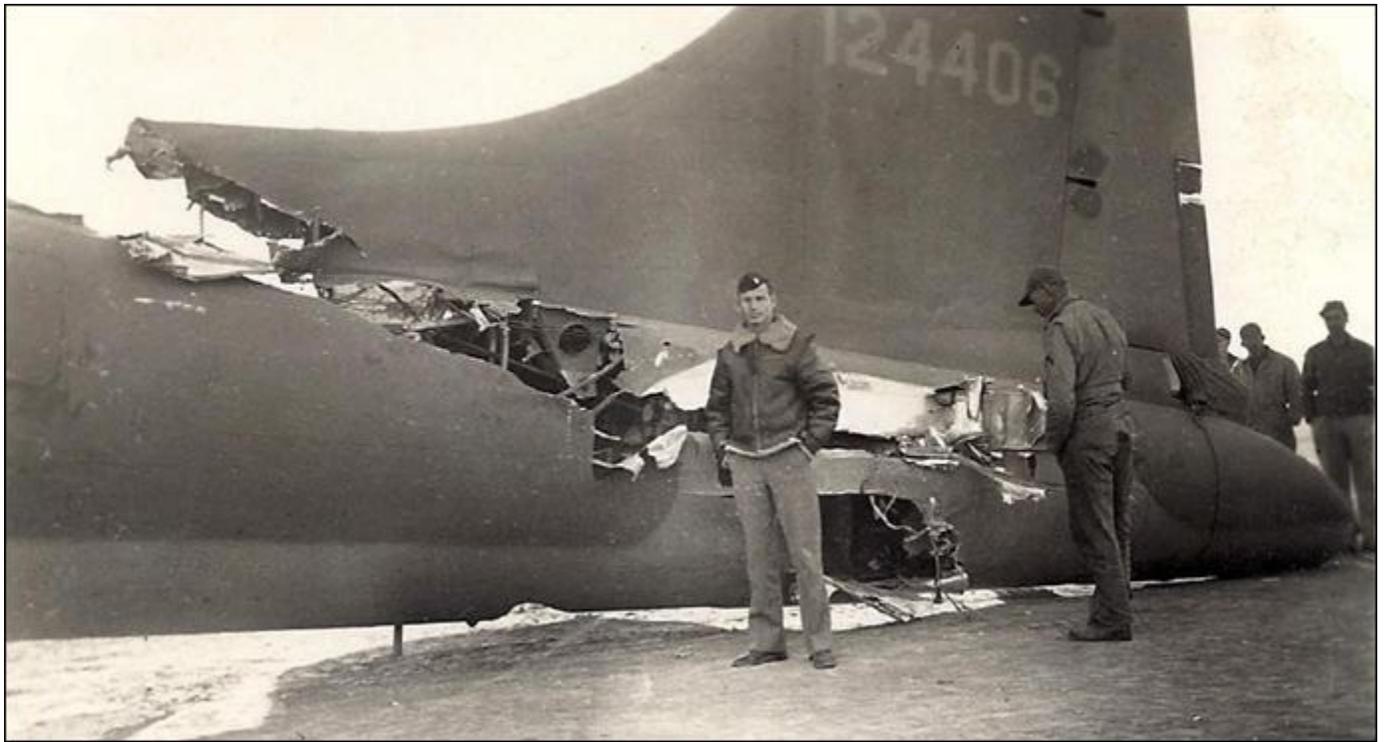
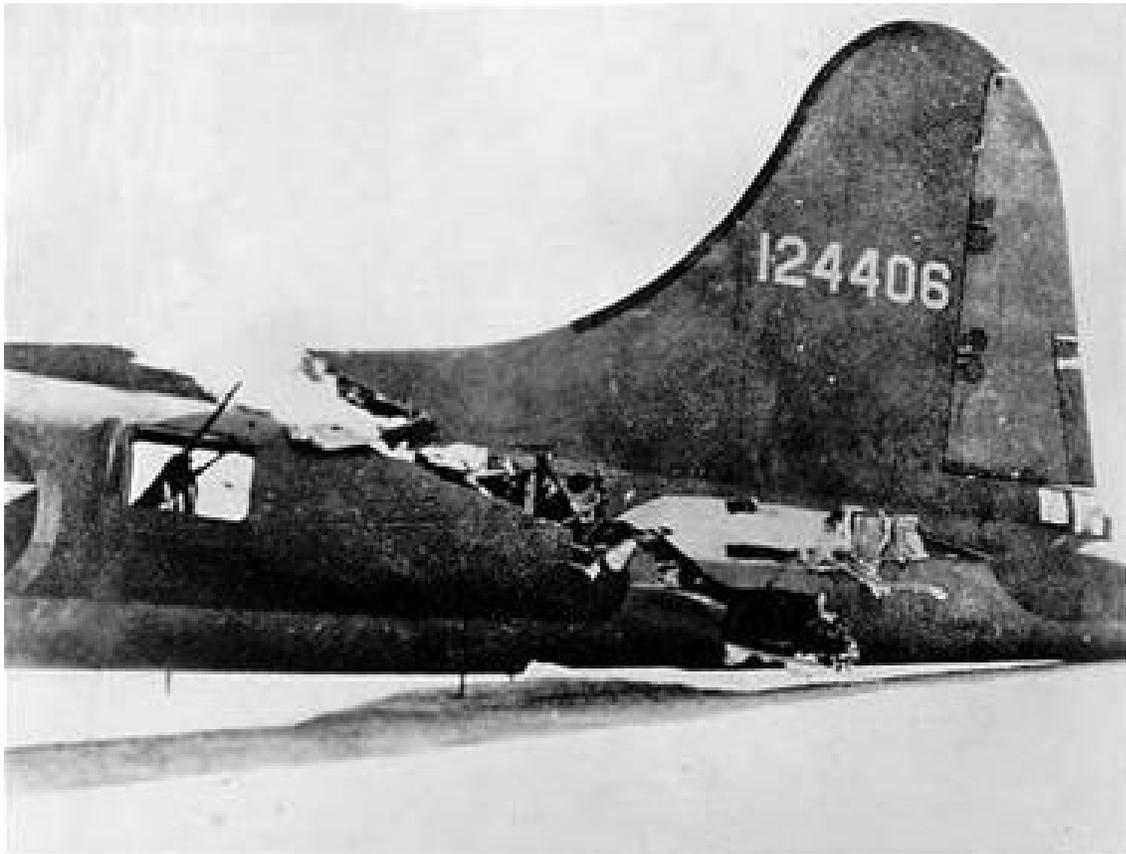
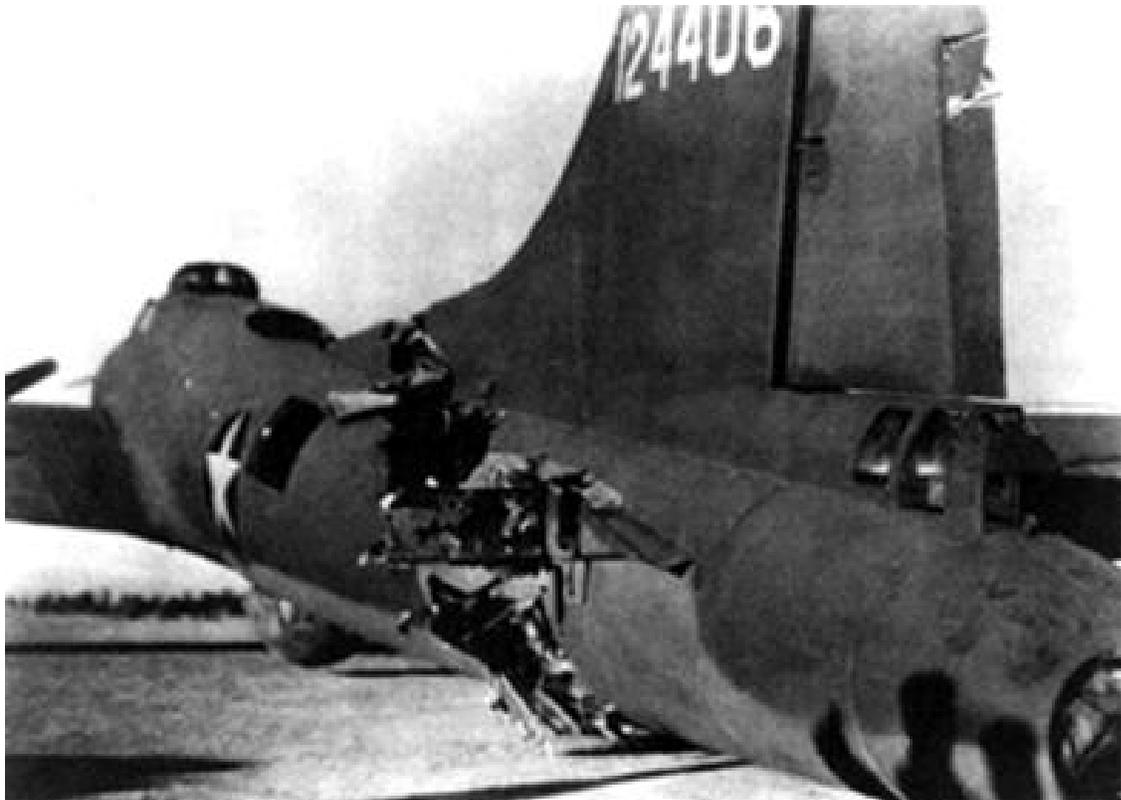
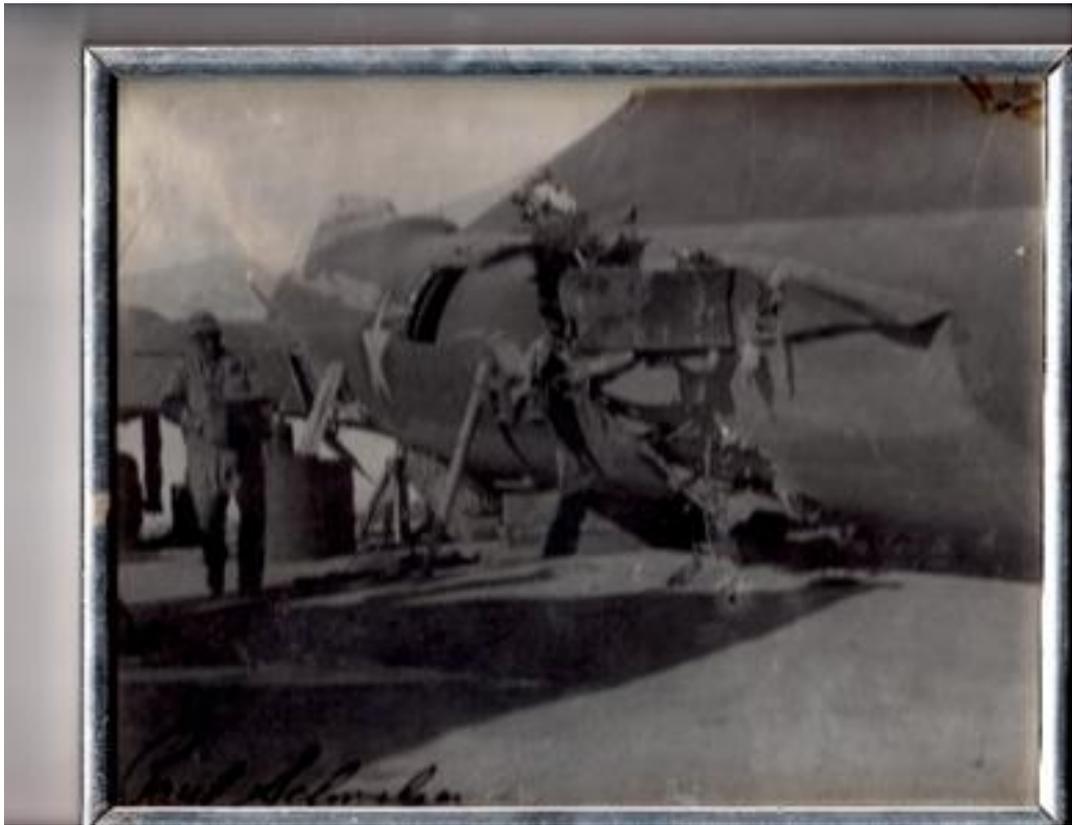
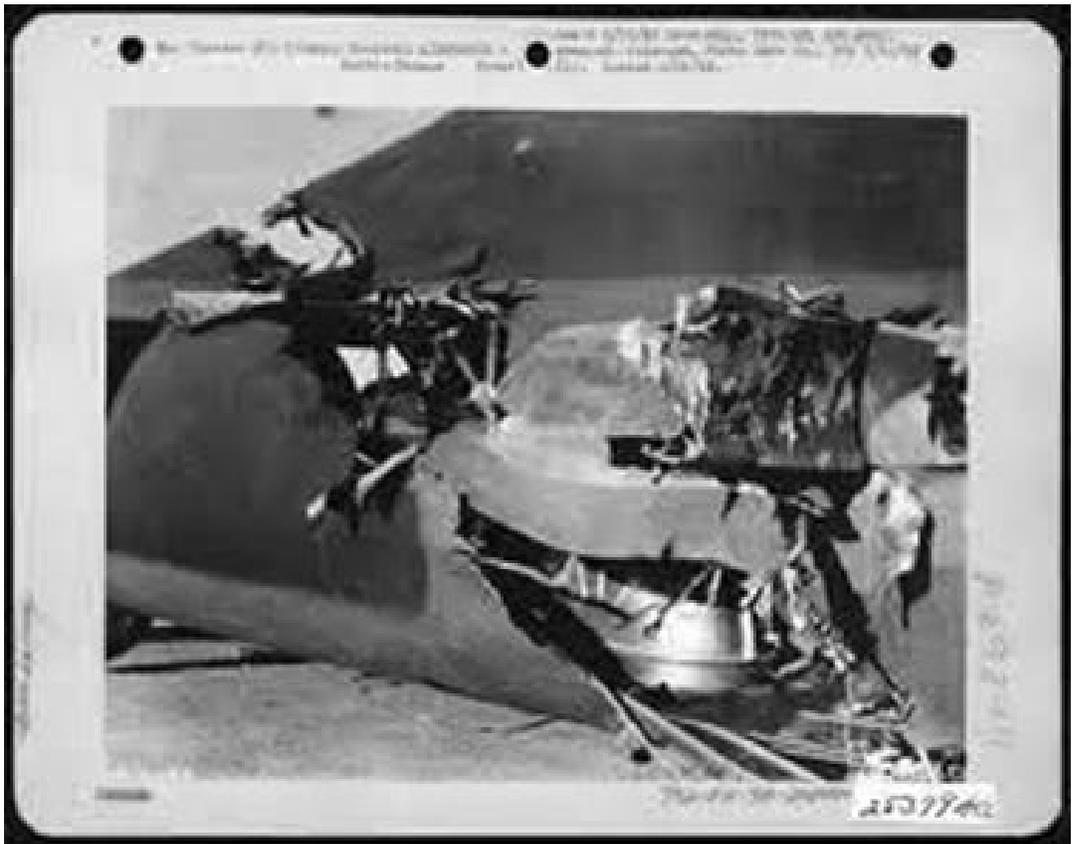
A mid-air collision on February 1, 1943, between a B-17 and a German fighter over the Tunis dock area, became the subject of one of the most famous photographs of World War II. An enemy fighter attacking a 97th Bomb Group formation went out of control, probably with a wounded pilot then continued its crashing descent into the rear of the fuselage of a Fortress named All American, piloted by Lt. Kendrick R. Bragg, of the 414th Bomb Squadron. When it struck, the fighter broke apart, but left some pieces in the B-17. The left horizontal stabilizer of the Fortress and left elevator were completely torn away. The two right engines were out and one on the left had a serious oil pump leak. The vertical fin and the rudder had been damaged, the fuselage had been cut almost completely through connected only at two small parts of the frame and the radios, electrical and oxygen systems were damaged. There was also a hole in the top that was over 16 feet long and 4 feet wide at its widest and the split in the fuselage went all the way to the top gunner's turret.

Although the tail actually bounced and swayed in the wind and twisted when the plane turned and all the control cables were severed, except one single elevator cable still worked, and the aircraft still flew - miraculously! The tail gunner was trapped because there was no floor connecting the tail to the rest of the plane. The waist and tail gunners used parts of the German fighter and their own parachute harnesses in an attempt to keep the tail from ripping off and the two sides of the fuselage from splitting apart. While the crew was trying to keep the bomber from coming apart, the pilot continued on his bomb run and released his bombs over the target.
